Changing vegetation and points of erosion over time
in the
Cannon Valley Wilderness Park

Mary, Jennifer and Hannah

Fall 2005

Introduction to Geology

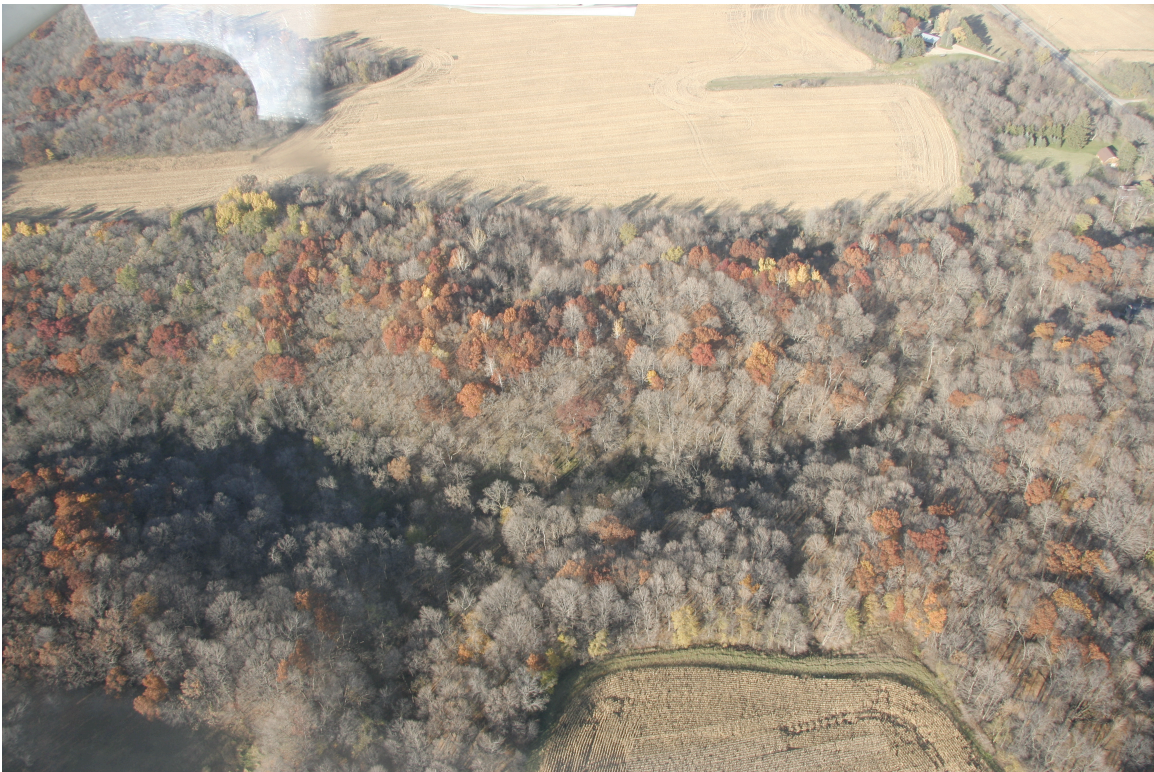
Back in the lab our group analyzed the aerial photos taken. From the photos, you can see the steep decline of the valley that slopes towards the riverbed. In the left corner of Figure 3 this decline is especially noticeable. In Figure 4 we can see where the riverbed and valley meet the Cannon River. Before reaching the Cannon, a small dip in elevation is noticeable. In all of the photos we also noticed that the trees are angled slightly inward, sloping towards the middle of the valley. Because it was fall when we took the photos, the trees were full of colorful leaves. Although this makes for beautiful pictures, it makes seeing the topography of the area extremely difficult. Because of this, we can only draw a few basic interpretations from the pictures. Our group also has plans to go up in the air again sometime next week when more of the leaves will probably have fallen off.

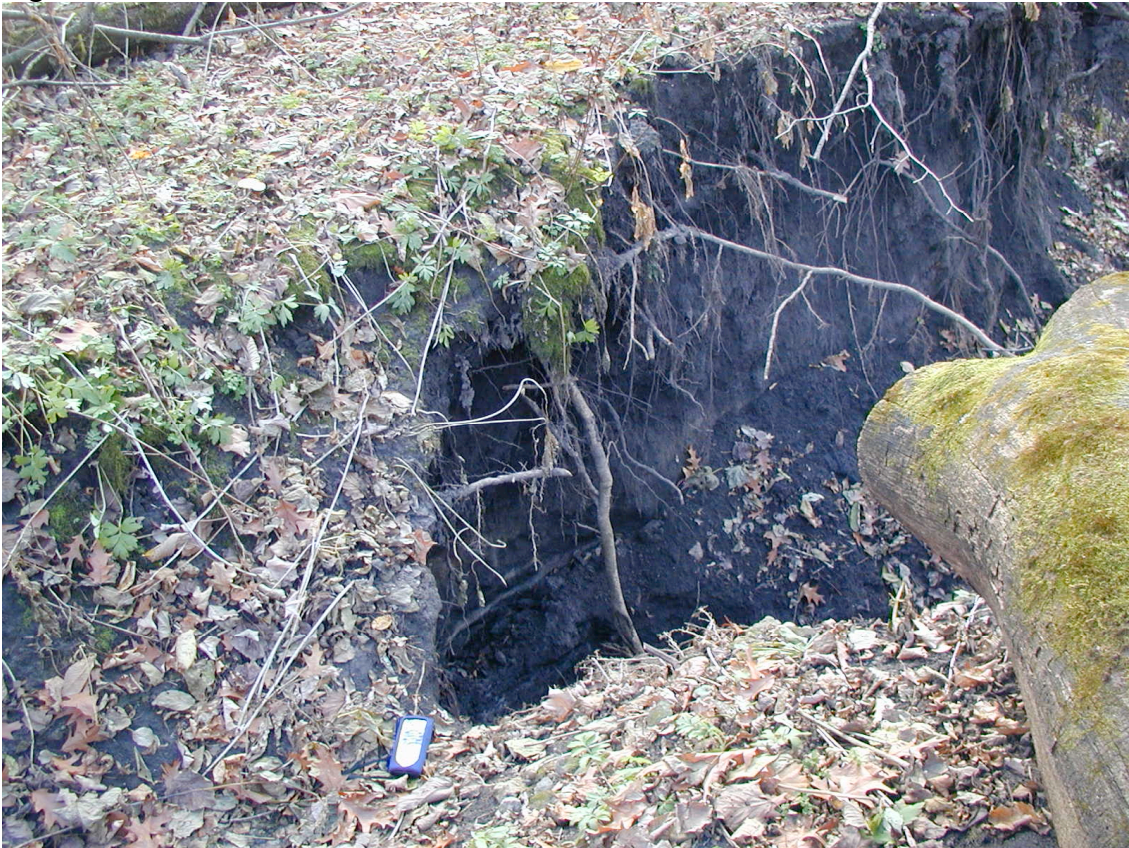
Figure 5 is a picture of the first nick-point after which the stream bed becomes narrow and deep. Until this spot, the stream has been a small dent in the gully, but here

is where it becomes difficult to climb out of. As this point is continually washed over with each rainfall, the dirt will be washed away and the stream will grow deeper farther downstream. This point is at UTM: 15T 0484541-4914509, and a second reading of 15T 0484577-4914495.

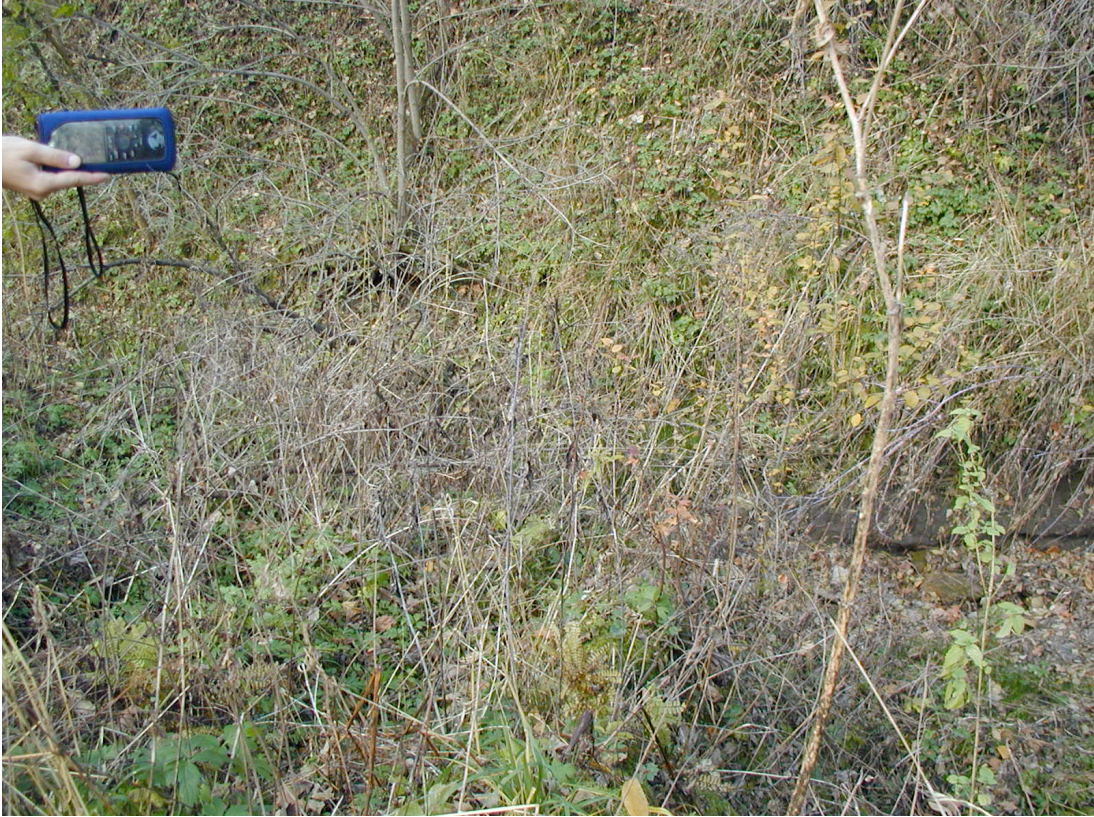
Figure 6

Figure 6, though not readily visible, is a picture is of a place in the streambed where there was once a wider shallower area, but now the water has now cut a smaller channel through it. The upper ledge has not seen any erosion or disturbances in a while, and so has become overgrown with foliage. It may happen that in the future heavy rains lead the stream to grow and return the small channel that holds the current drainage, to the size it must once have had from the presence of this site. UTM: 15T 0484509-4914532.

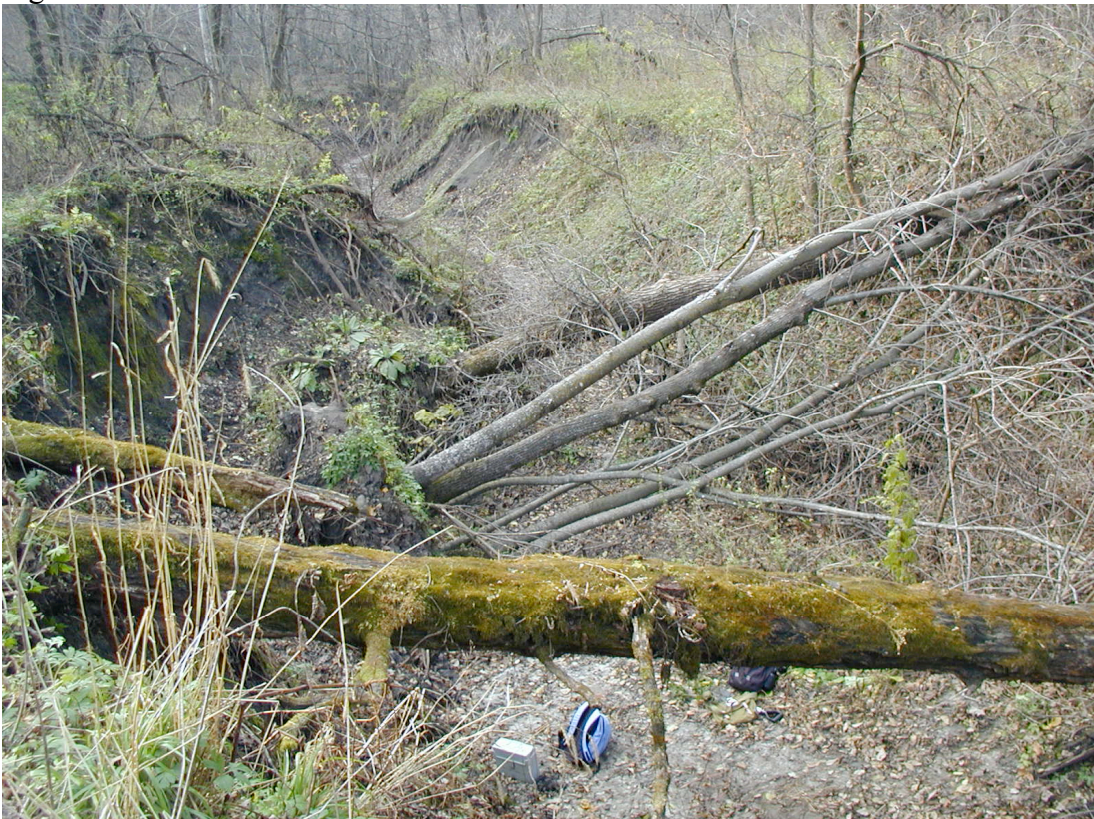
The trees in Figure 7 appear to have fallen relatively recently. Some evidence of this is that there is a considerable amount of dirt still attached to the roots. It's most likely that the tree's root system held the bank together while water flowing around it eroded the support away until they fell in the direction that was weakest (i.e. where the water flow was heaviest, directly parallel to the stream). We believe other trees along the bed, such as those seen in Figures six and seven, will eventually fall much as these ones did.

GPS Location: UTM 15T 0484597-4914497 and 15T 0484507-4914501

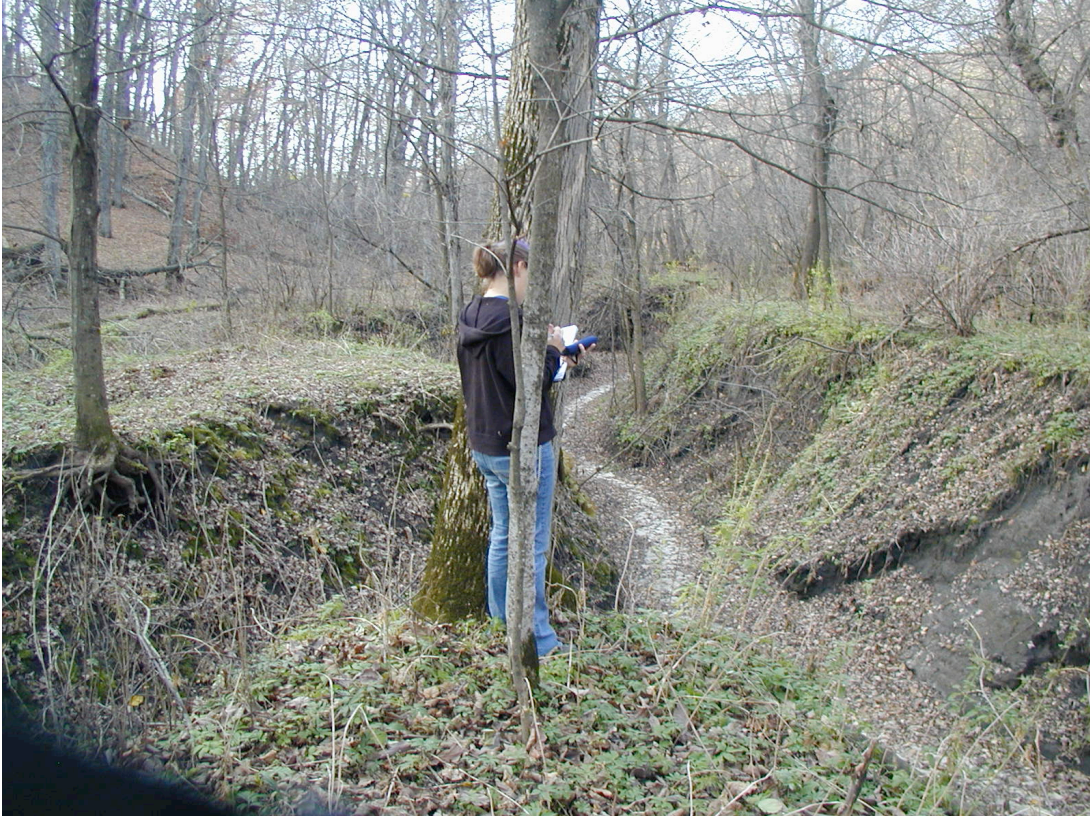
Figure 8 shows the point at which another streambed intersects with the major one that we followed. Where the person in the picture is standing is the tip of the land that juts into the intersection. The sides of the banks are both rather steep at this particular stretch of the bed. This means that the composition of the soil in this area is more easily eroded than in other areas where the bed is very shallow. According to the GPS units

used to pinpoint the location of this intersection, the coordinates are UTM 15T 0484461-4914566.

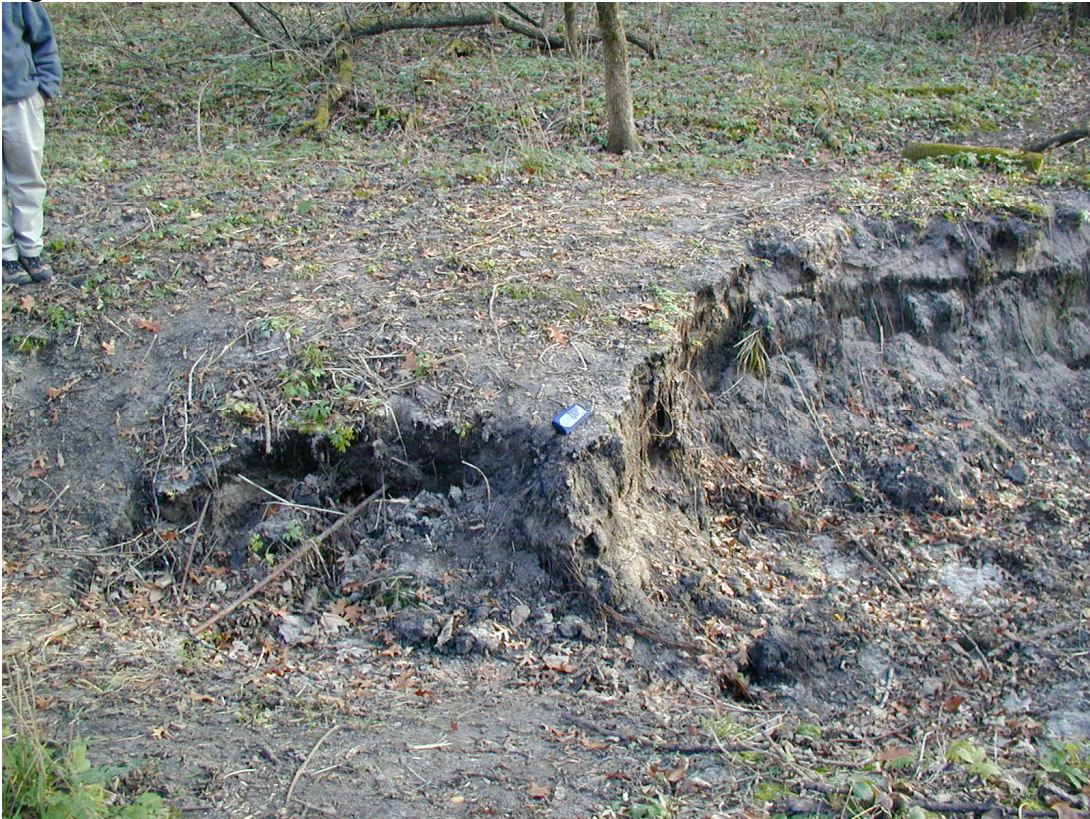
Figure 9 is a photo of another nick point or a point where there exists a difference in the degree of erosion. At this nick point, the bed of the stream suddenly becomes deeper. This could show that the composition of the soil in the area above the nick point is slightly more difficult to erode than that of the area below where the water has been able to more easily erode away the soil. Figure 10 shows the nick point from another angle, looking at it from the more eroded side of the streambed. A helpful way to measure erosion or change in an area is to monitor its nick points. Even in the few weeks that we have been studying the area, we have noticed that this particular nick point is considerably changed. It is even more eroded than before. The GPS coordinate for this nick point are UTM 15T 0484276-4914543

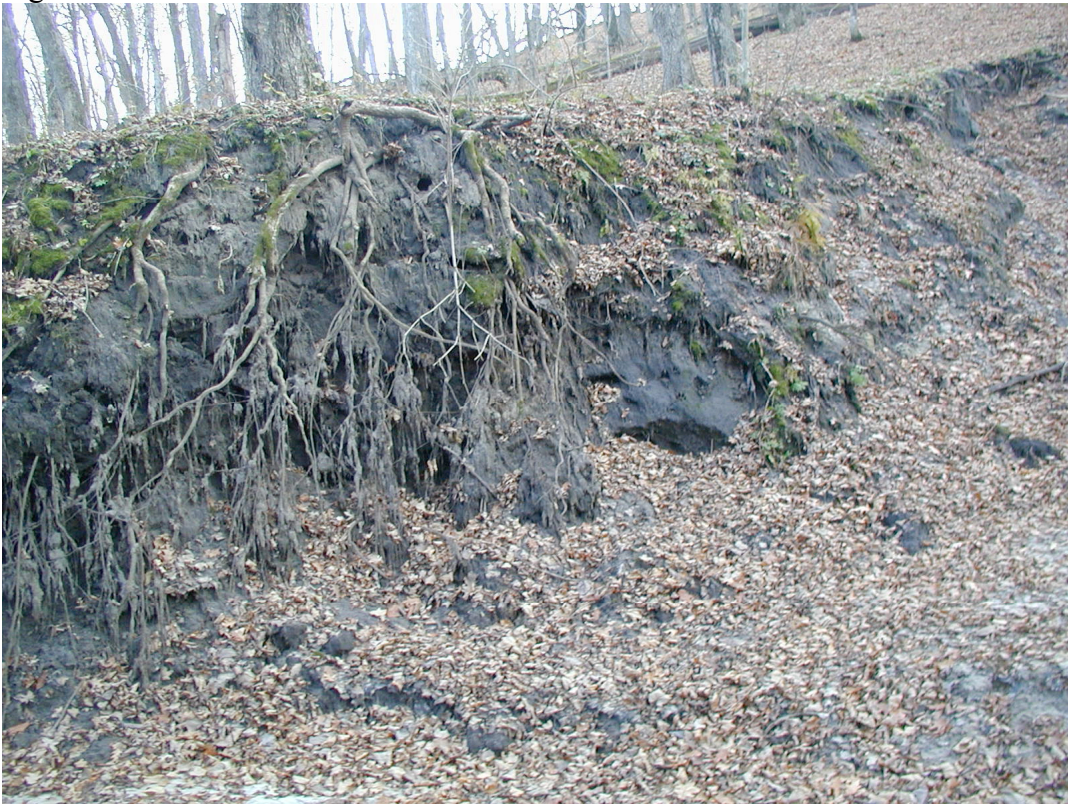
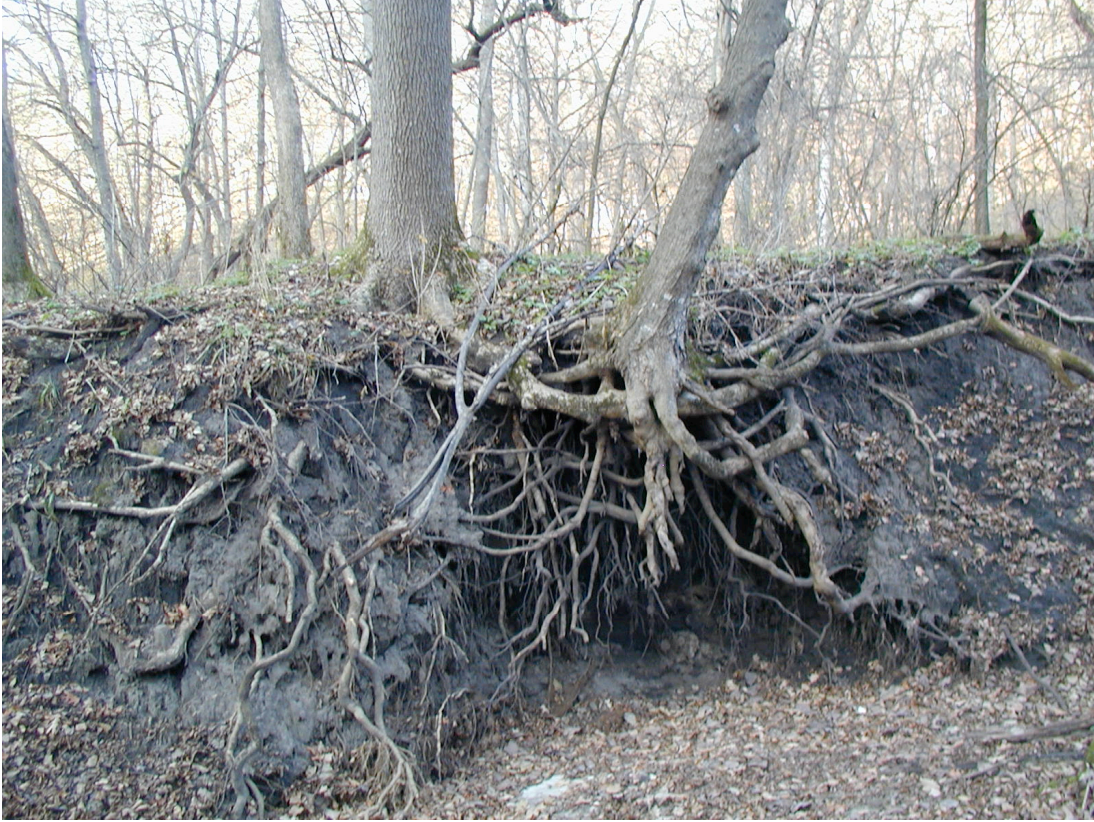
Figures 11 and 12 are of trees and their roots that are in the line of erosion of the stream bed. The trees are located approximately across the bed from each other at the GPS location of UTM 15T 0484424-4914514. It can easily be said that they will soon end up like those trees in Figure 7. These trees provide another obvious way, other than nick points of measuring the degree of erosion in a specific area. It will be interesting to see how long it takes for the trees to completely topple over. The same case is true for several of the trees that line this bed. At the rate of erosion that seems to be occurring, some of them will not remain upright for much longer.
